# Mission report of the field work at Lakes Nyos and Monoun (December, 2014)

Within the framework of regular monitoring of Lakes Nyos and Monoun of SATREPS Ny-Mo project, a nippo Cameroonian team visited, from 03th to 12th December, lakes Nyos and Monoun for the regular annual monitoring. The overall objectives of the mission was to ensure the transfer of knowhow to IRGM team by the Japanese were:

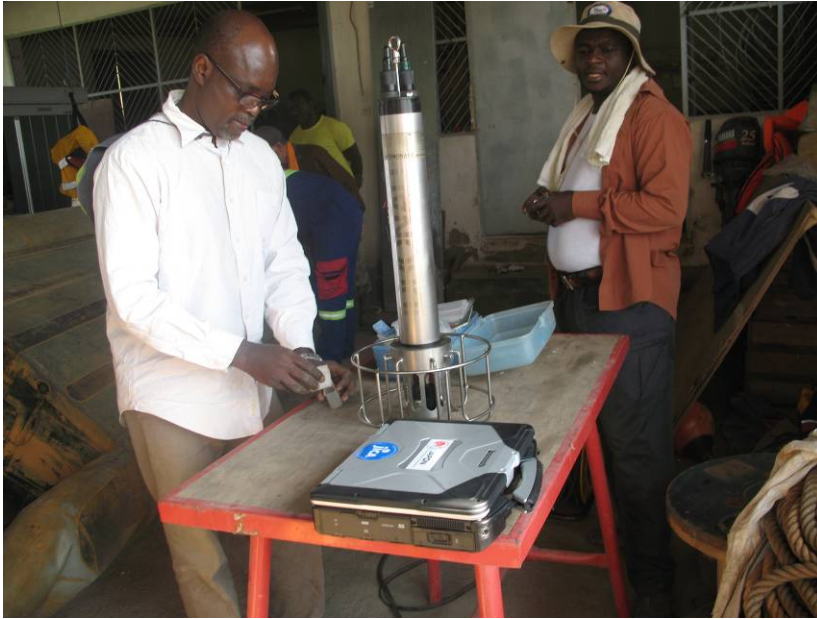
During the field work, it was not possible to do CTD because of a problem of communication with the Thoughtbook. Two other laptops were then requested. However, it was not possible to use them because of the lack of the USB adaptor.

Figure 1: Testing of switching on of the CTD by the Cameroonians team

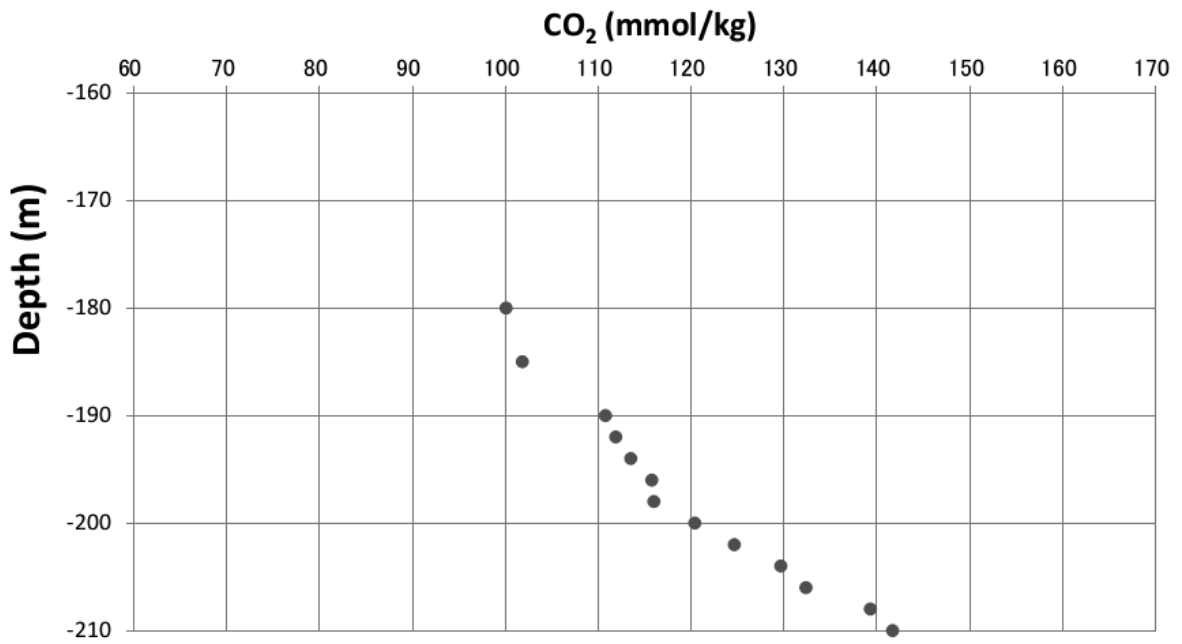
Using the YY-method, we measured the parameters at Lake Nyos on December 6<sup>th</sup>, 2014 and Lake Monoun on December 10<sup>th</sup>, 2014. The depths of the lake bottoms were 210 m at Nyos and 99 m at Monoun. At Nyos, the measurement started at the depth 210 m and ended at 180 m where the gas self-lifting ceased. At Monoun, we started at depth 99 m and ended at depth 91 m. The results are shown in Fig.2 and Fig.3.

Figure 2: Distribution of dissolved CO<sub>2</sub> concentrations at Lake Nyos,

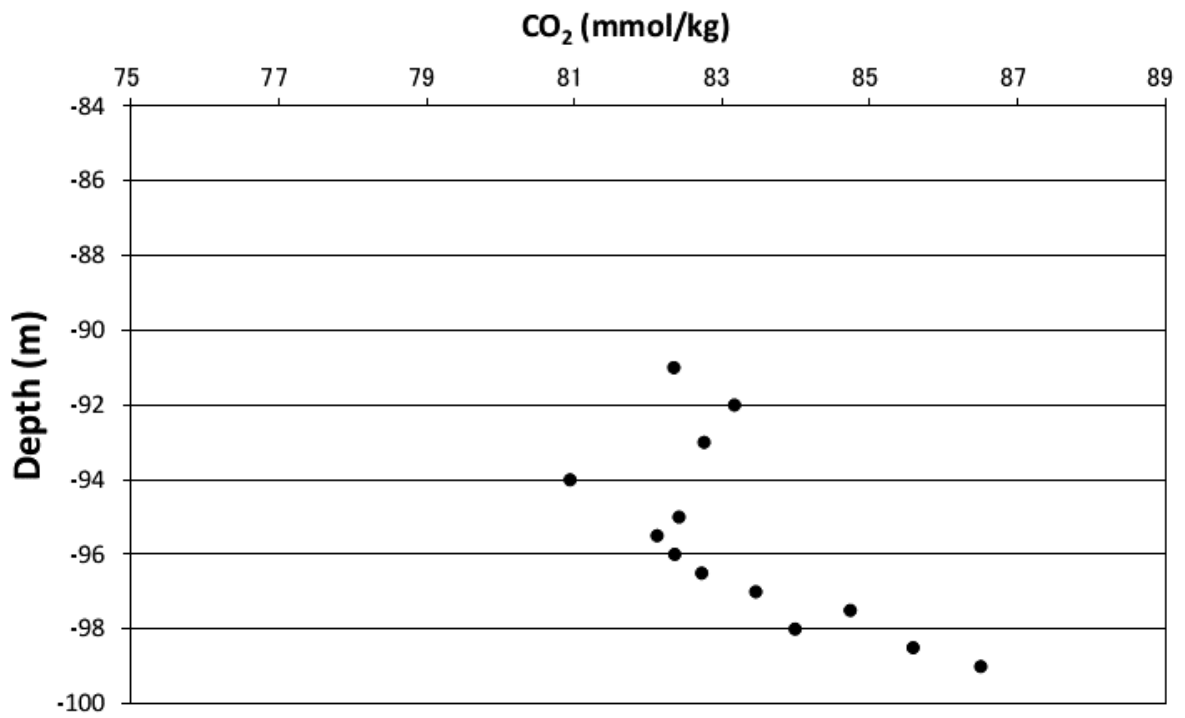
Figure 3: Distribution of dissolved CO<sub>2</sub> concentrations at Lake Monoun

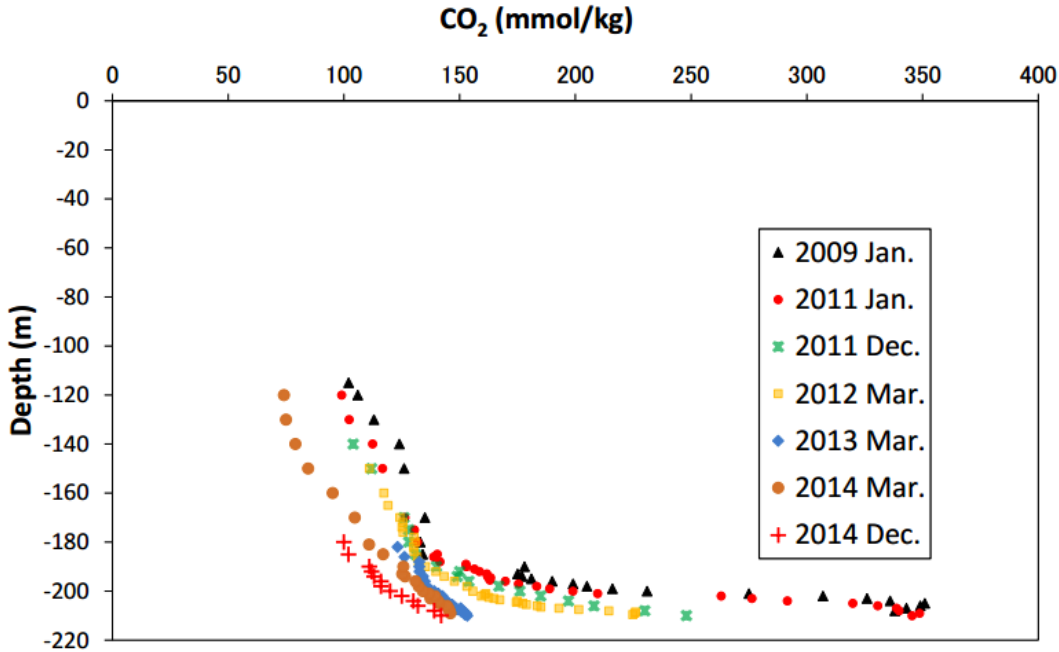
Figure 4 and 5 show the distribution of dissolved CO<sub>2</sub> at the both lakes in time.

Figure 4: Comparison between 2009, 2011, 2012, 2013 and 2014 CO<sub>2</sub> profiles at Lake Nyos.

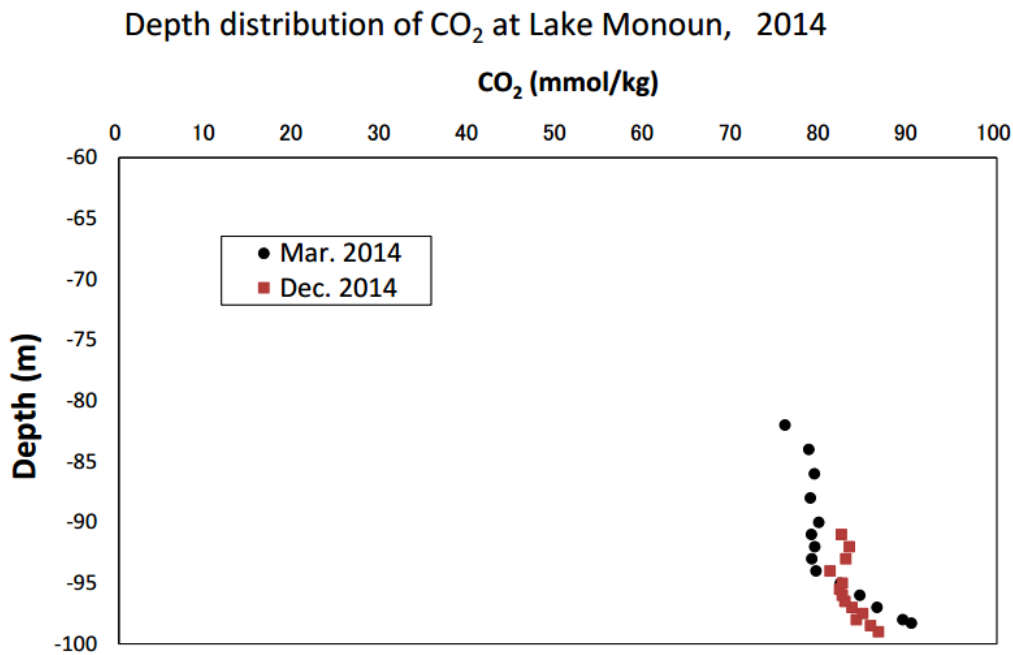
Figure 5: Distribution of CO<sub>2</sub> in March and December 2014 at Lake Monoun

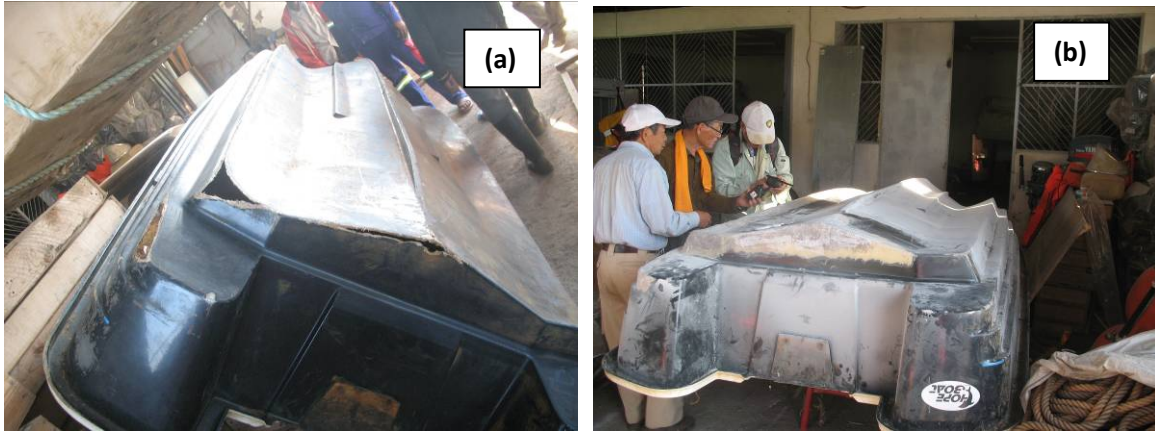
Figure 6: Damaged boat at Lake Nyo before (a) and after (b) repair by Mr Nishio

The damaged RPF boat at Lake Nyos was thoroughly fixed by Mr Nishio. He also maintained some engines. Subsequently, he trained the local workers of lakes Nyos and Monoun and maintenance of the boats and the engines continued during this mission.

The maintenance techniques of the two damaged boats (Lake Nyos, Fig.6), the engine and the engine powered winch were transferred to local workers by Mr Nishio. They have also benefited advised on how to sustainably use and maintain donated and used equipment

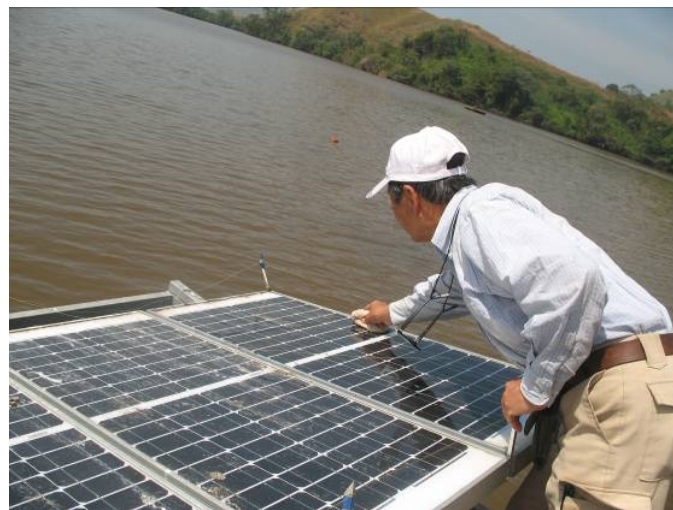
The solar power-driven deep water removal system is working well. The flow rate of water measured and the output of solar modules are from 2.9 to 3.2 m<sup>3</sup>/h and 0.23 kW, respectively. Estimated total flow rate of deep water through a pump and an annulus was more than 100 m<sup>3</sup>/day (about equal to that of this March). After all checks, the solar panels were cleaned (Fig.7).

Figure 7: Cleaning of the solar panels
