# PRELIMINARY REPORT ON THE SATREPS PROJECT

## JUNE 2012 AND JANUARY 2013 FIELD EXPEDITION TO LAKES NYOS AND MONOUN, CAMEROON

*Japanese-Cameroonian SATREPS Project on Safety, Rehabilitation, and Development of the Lakes Nyos and Monoun areas in Northwest Cameroon. American participation by the U.S. Geological Survey and the University of Michigan*

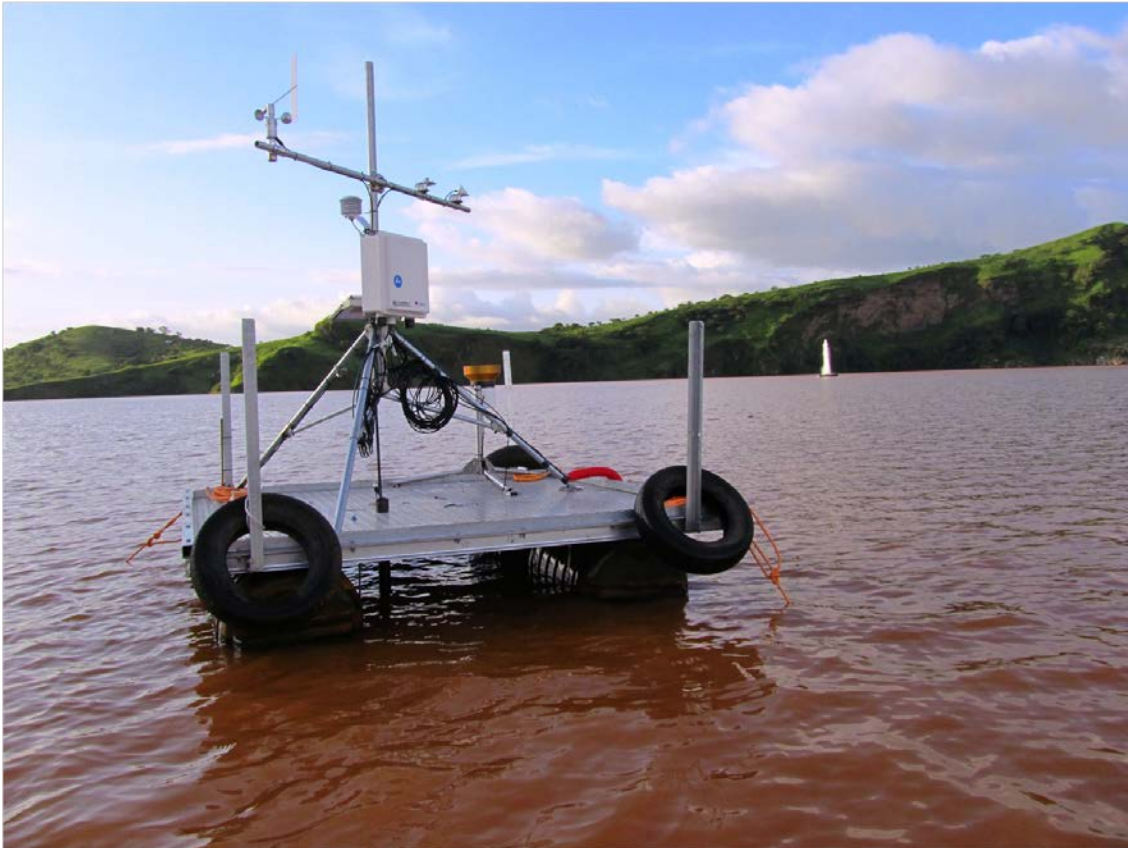
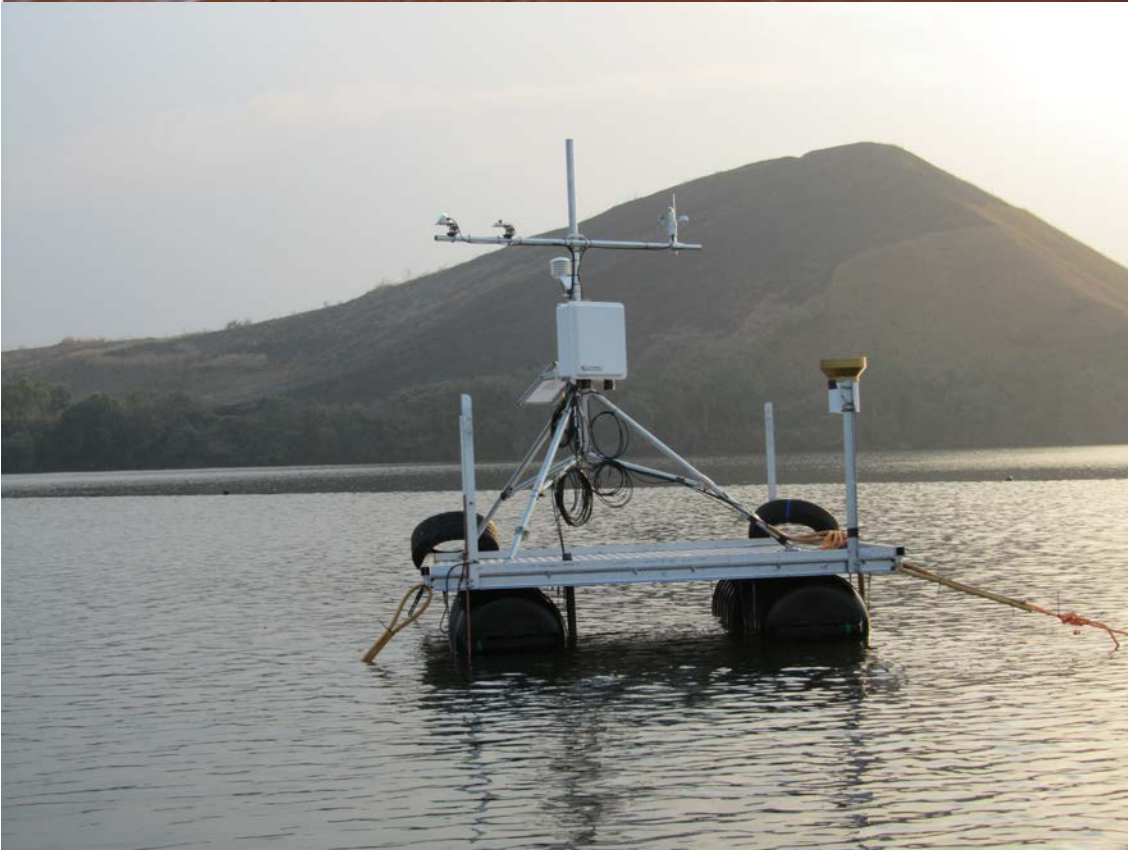
**Figure 1.** Climate monitoring station anchored in Lake Nyos (top) and Lake Monoun (bottom).

- (1) In June 2012 we installed a climate station at Lake Nyos on a floating platform built by our Japanese colleagues. Sensors were installed to monitor the air temperature and humidity, the wind speed and direction, the incoming solar radiation, the barometric pressure, and rainfall. In addition, sensors were installed in the lake to monitor water temperature, salt content, and the pressure of total dissolved gases (including carbon dioxide, CO<sub>2</sub> and methane, CH<sub>4</sub>) at two depths in the lake (Figure 1).

- (2) On our second trip in January 2013 we installed a floating platform on Lake Monoun to measure the same basic climate variables as measured at Lake Nyos. Similar to the station at Nyos, sensors were installed to monitor the water temperature, salt content, and the pressure of dissolved gases (carbon dioxide, CO<sub>2</sub> and methane, CH<sub>4</sub>) at two depths in the lake (Figure 1).

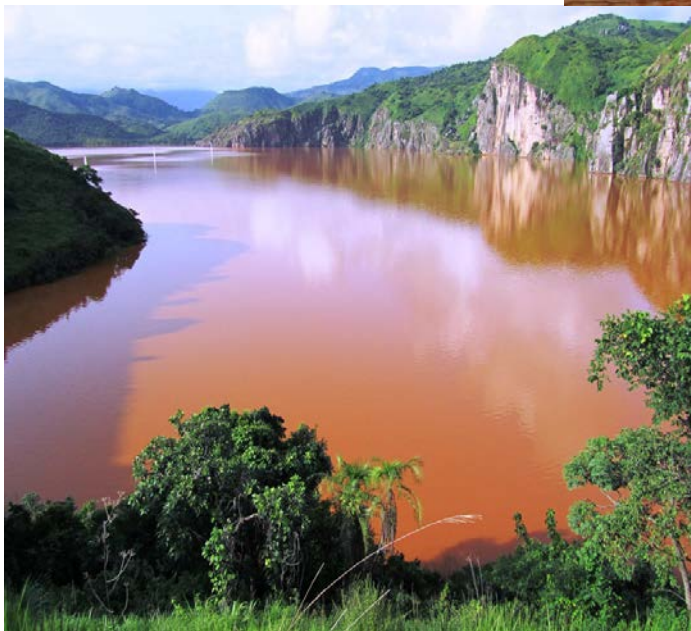
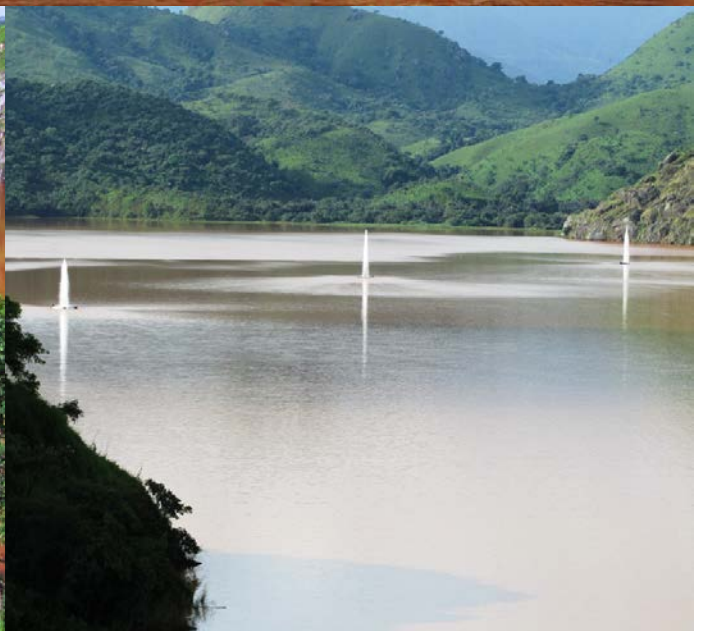
**Figure 2.** Degassing pipes at Lake Nyos. The first pipe was installed in 2001 as part of the USAID – OFDA project with Japanese, Cameroonian, and French scientists and engineers. In 2010 two additional pipes were installed by a French company using money provided by the Cameroonian government.

The red color of the lake is due to dissolved iron in the lake bottom waters that is brought to the surface by the degassing pipes. At the surface the iron contacts oxygen and forms iron-hydroxide (“rust”) which colors the water.

- (4) The three degassing pipes continue to operate in Lake Nyos (Figure 3). Measurements of the total gas pressure in Lake Nyos showed that the degassing operation is steadily reducing gas amounts in the bottom of the lake. The gas pressure at the deepest part of the lake has been reduced by ~2.5 times from a maximum content in 2001 when the first pipe was installed (Figure 4). The total CO<sub>2</sub> in the lake has been reduced by 40% since 2001, from ~710,000 to 425,000 metric tons (Figure 5).

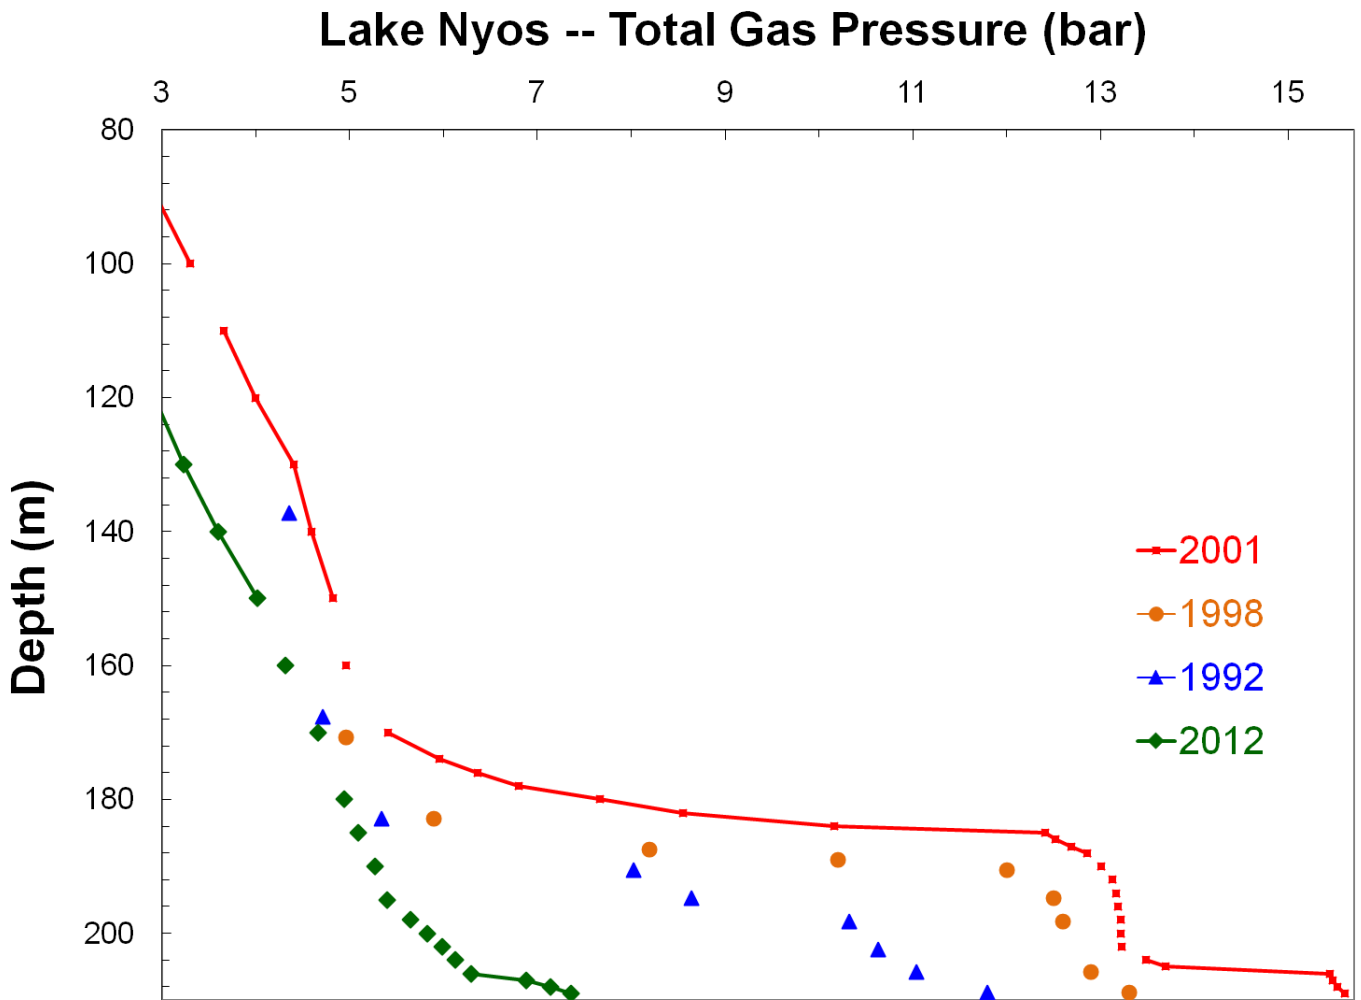
**Figure 4.** Profile of total gas pressure ( $\text{CO}_2$  plus  $\text{CH}_4$ ) in the bottom waters of Lake Nyos. The gas pressures increased from 1992 to 1998 to a maximum in 2001 (red line) when the first degassing pipe was installed. In June 2012 the profile (green diamonds) shows the gas pressures at the bottom of the lake have been reduced by ~2.5 times from the maximum in 2001.

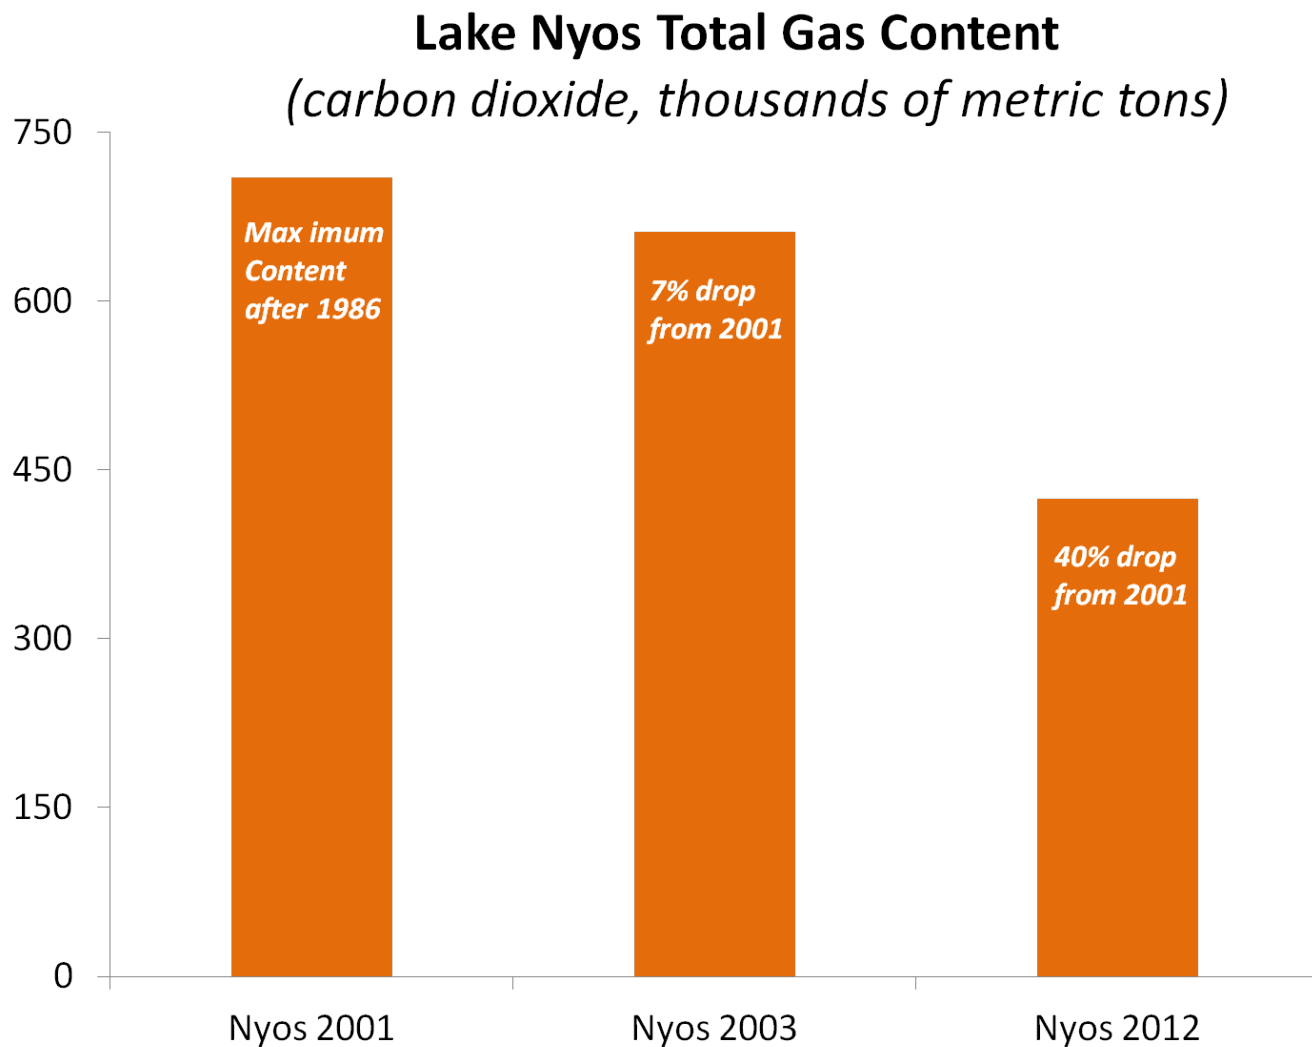
**Figure 5.** Total amount of CO<sub>2</sub> in Lake Nyoos in 2001 (maximum content after the 1986 gas disaster) was reduced by ~ 7% by 2003 with the pipe installed in 2001. Two more pipes installed in March 2011 have further reduced the gas content to 40% of the maximum held in the lake in 2001.

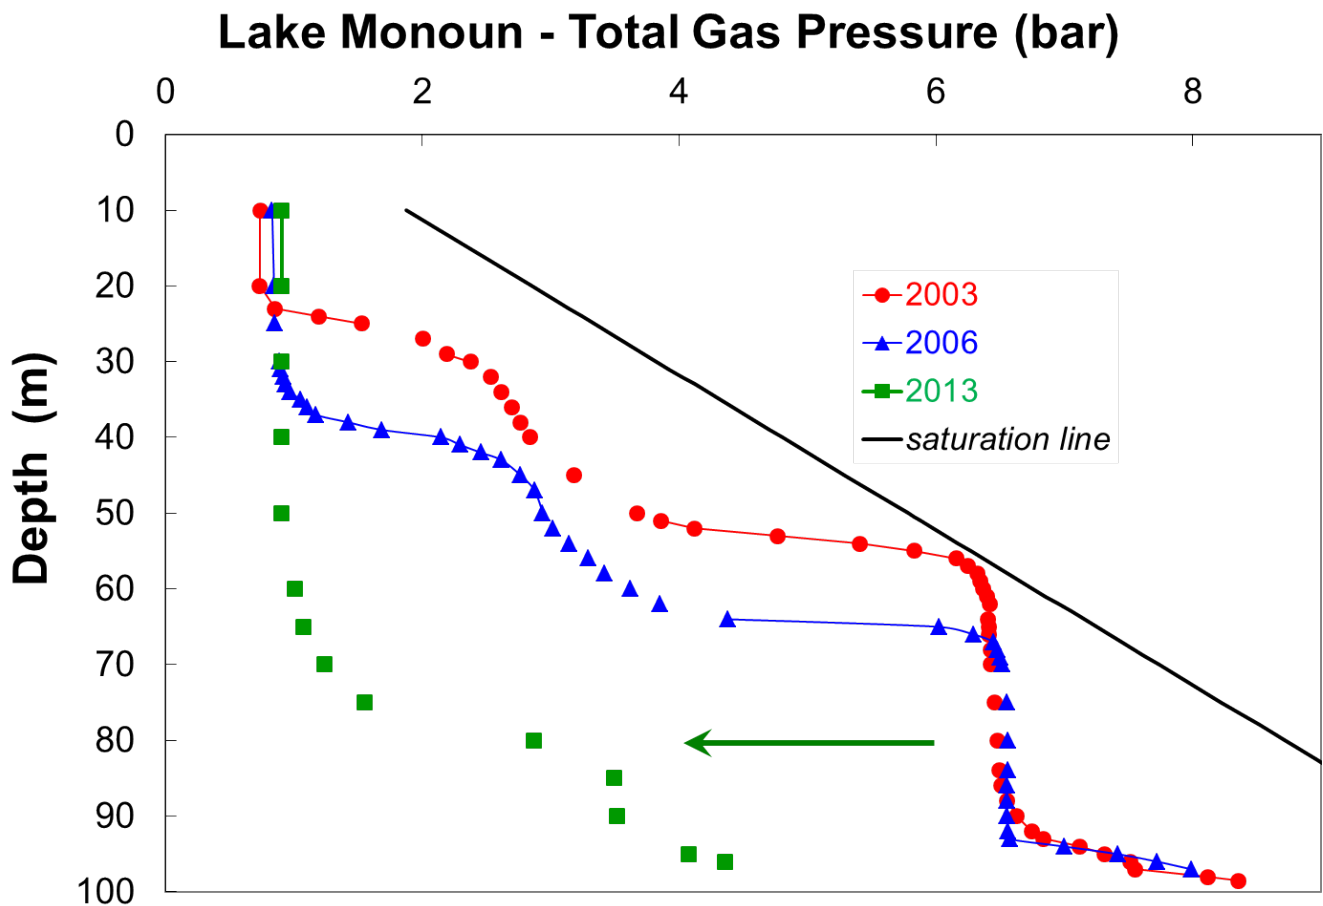
**Figure 6.** Profile of total gas pressure (CO<sub>2</sub> plus CH<sub>4</sub>) in the bottom waters of Lake Monoun. The gas pressures were highest in 2003 just before the first degassing pipe was installed. Gas pressures dropped by 2006 and by January 2013 the lake has essentially been degassed. Although gas pressures at the very bottom (below where the degassing pipe inlet reached) are still ~4 bar, the amount of water in this deepest part of the lake is very small and the total amount of gas contained constitutes no danger at this time for the surrounding populations.

- (5) Measurements in January 2013 of the total gas pressure in Lake Monoun show that the prior degassing has reduced gas amounts in the bottom of the lake (Figure 6). The lake is now considered to be “safe” for the surrounding population. The installed climate station on the lake will help to monitor any future build up of gas.

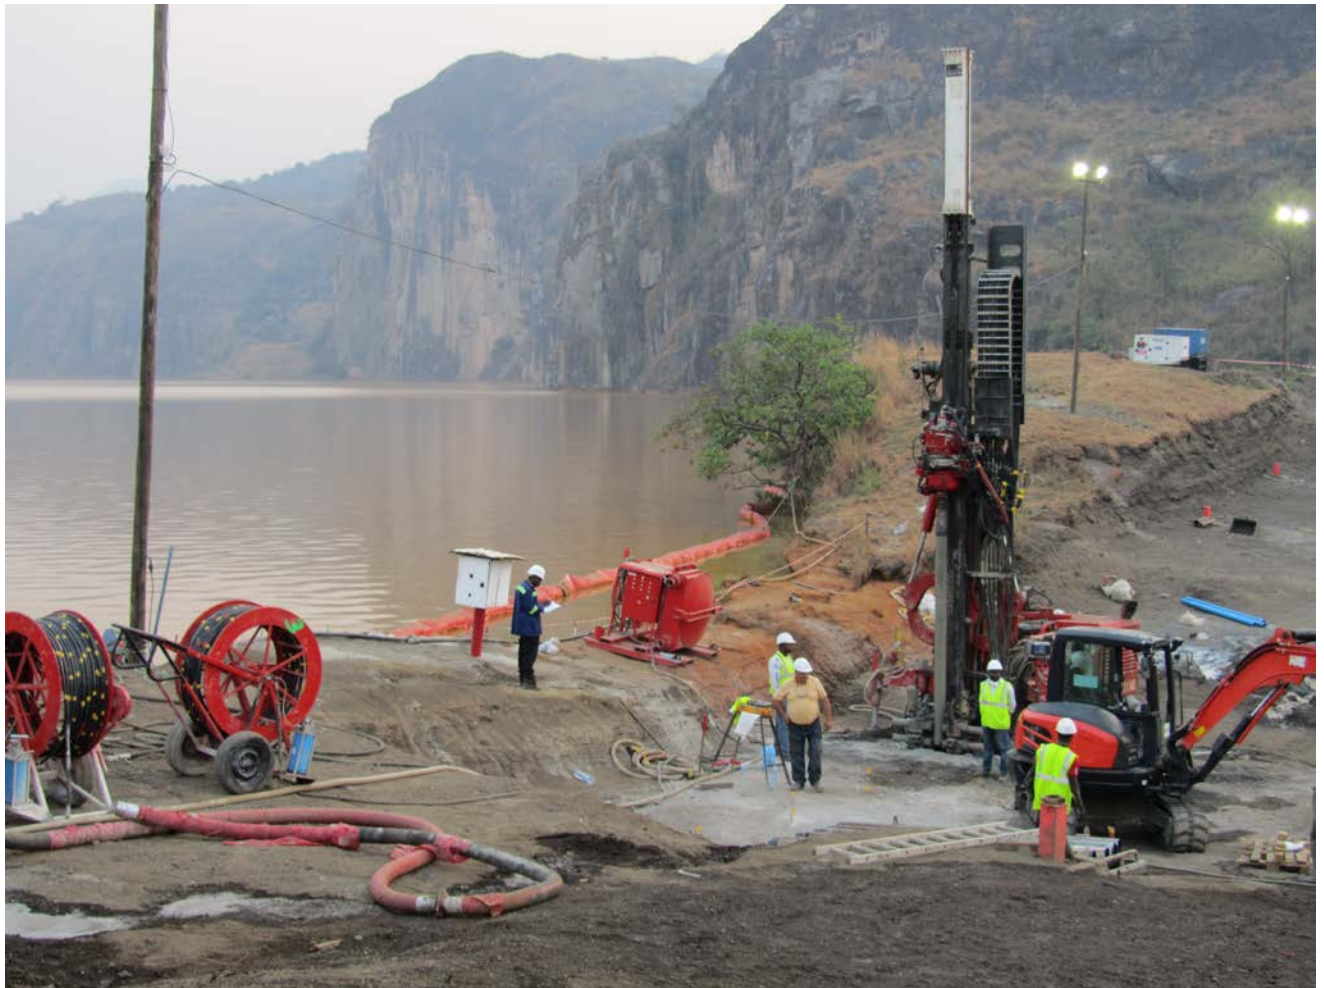
**Figure 7.** Operations to strengthen the weak natural dam at Lake Nyos include drilling into the dam and injecting liquid cement in order to stabilize the dam and prevent leakage of lake water through the dam. This picture was taken on 22 January 2013 and shows the drilling process across the dam.

- (6) Although we are not directly involved, we can report that operations have begun at Lake Nyos to strengthen the weak natural dam impounding the upper 40 m of the lake (supported by the EU and Cameroonian government) (Figure 7). Liquid cement will be injected into the dam and when it sets it will prevent further leakage of lake water through the dam which causes erosion. This strengthening will reduce the danger of the dam failing and creating a flood that could reach into Nigeria and affect from 5,000 to 10,000 people below the lake.
