Mission Report

By Seigo OOKI

In this period from 21st Oct. to 14th Nov., we did maintenance of analytic equipment in Nkolbisson Laboratory. We mainly took a long time on AAS (Atomic Absorbance Spectrometer) and PICARRO (Water Isotope Ratio Laser Analyzer). In this report, I will write the problems we found and how they were solved.

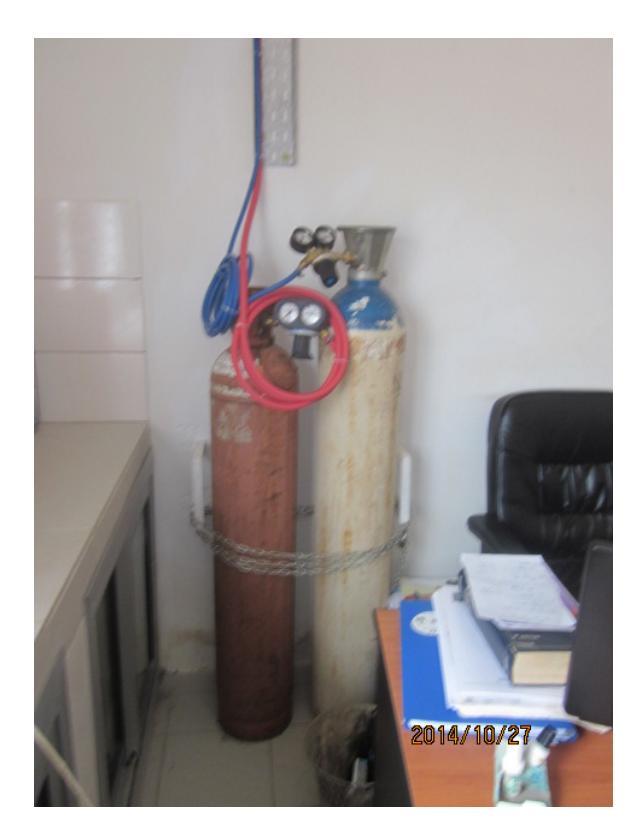
Fig.1 Present gas position

Before coming to Nkolbisson, C_2H_2 and N_2O gas cylinders were kept on the floor with lying on. This situation is dangerous especially in case of N_2O gas cylinder, which is kept with liquid gas condition. The liquid N_2O may leak from port of cylinder and cause damage to regulator. Then, we changed these gas positions in Fig.1. Furthermore, we could see that N_2O gas pressure was increasing when we opened main gas valve. Before changing gas position, we could not confirm the pressure increasing. This indicates that the misunderstanding of no N_2O gas was caused by an incorrect gas cylinder position.

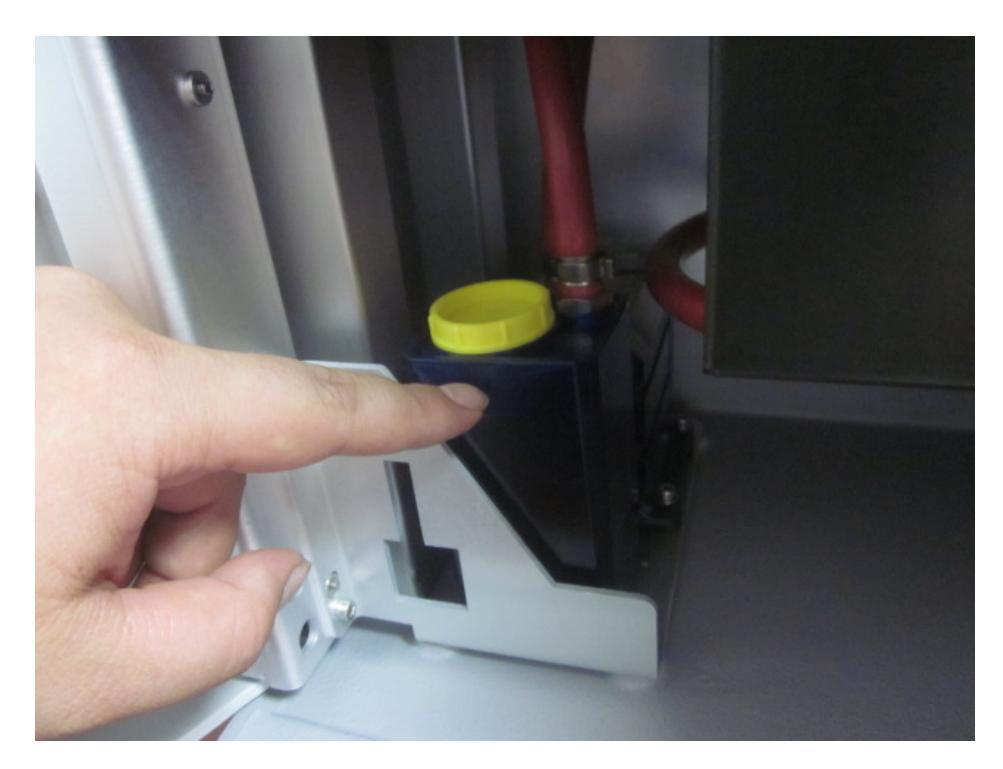
Fig.2 Xe-lamp cooling system

words, all analysis is impossible. Normally, Xe-lamp is ignited automatically when we start to setup. But, when we started the setup, we could confirm an error message informing cooling water was too low and Xe-lamp did not ignite. Xe-lamp of AAS can not work under the temperature is over 60°C. Then we checked cooling system (Fig.2) and the cooling water was almost empty. After putting tap water, that error message never appeared (Fig 2) and we could proceed to next maintenance. But after two weeks, cooling water decreased again to half volume. This means we need to constantly check cooling system.

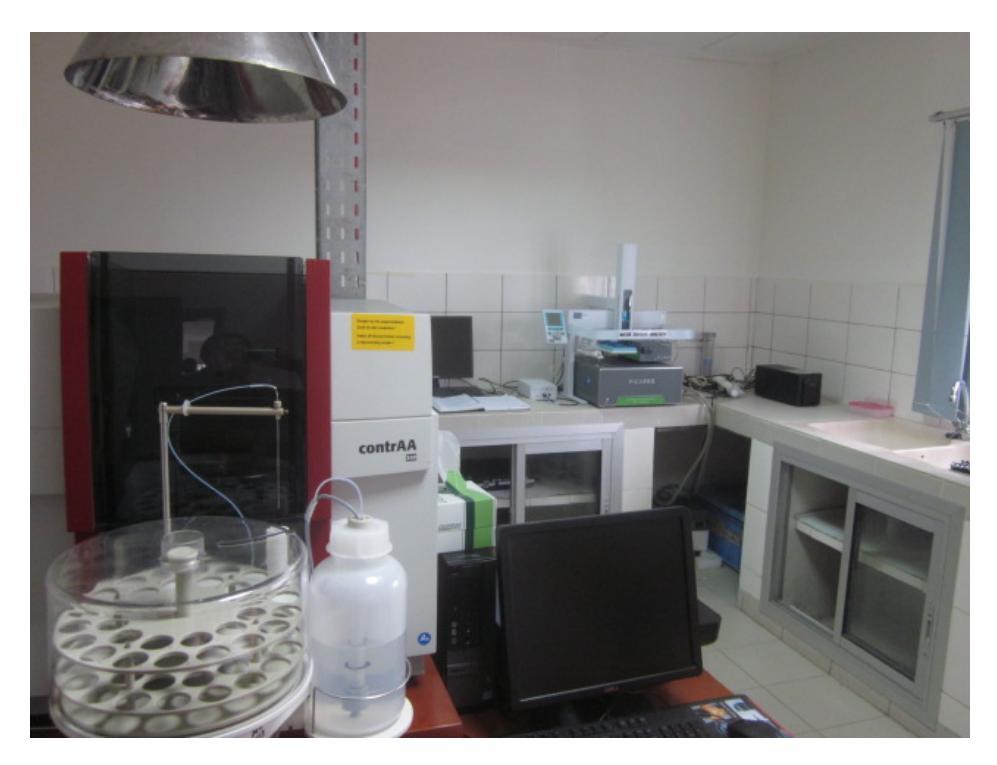
Fig.3 Previous PICARRO location

PICARRO is recommended to install in place that is not warm because data analysis is often affected by heat. Just before, PICARRO has been set near AAS in same room (Fig.3). Then, we moved PICARRO to a new room locating in opposite side (Fig.4). After moving, we started the normal setup procedure. But, error message informing a wrong valve connection occurred. So, we reconnected all cables and tubes. Then we found we needed to connect vacuum valve more tightly. After all, error message never appeared and we concluded that the installation mission was a success.

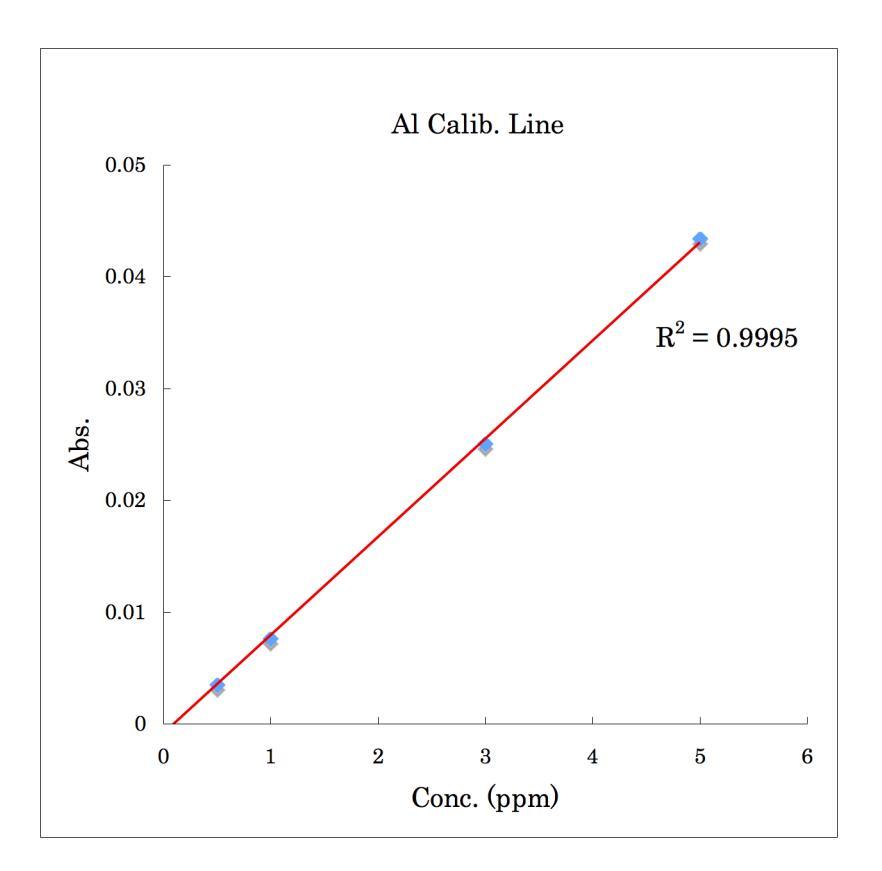
Element: Al with C_2H_2 - N_2O

About AAS, we tried to make calibration curve of Al, Ca, Si, Mg and Mn. We will show results and each calibration curve.

Concentration (ppm)	Absorbance	Standard division
0	-0.00038	0.00016
0.5	0.00348	0.00029
1.0	0.00763	0.00026
3.0	0.02505	0.00059
5.0	0.04339	0.00024

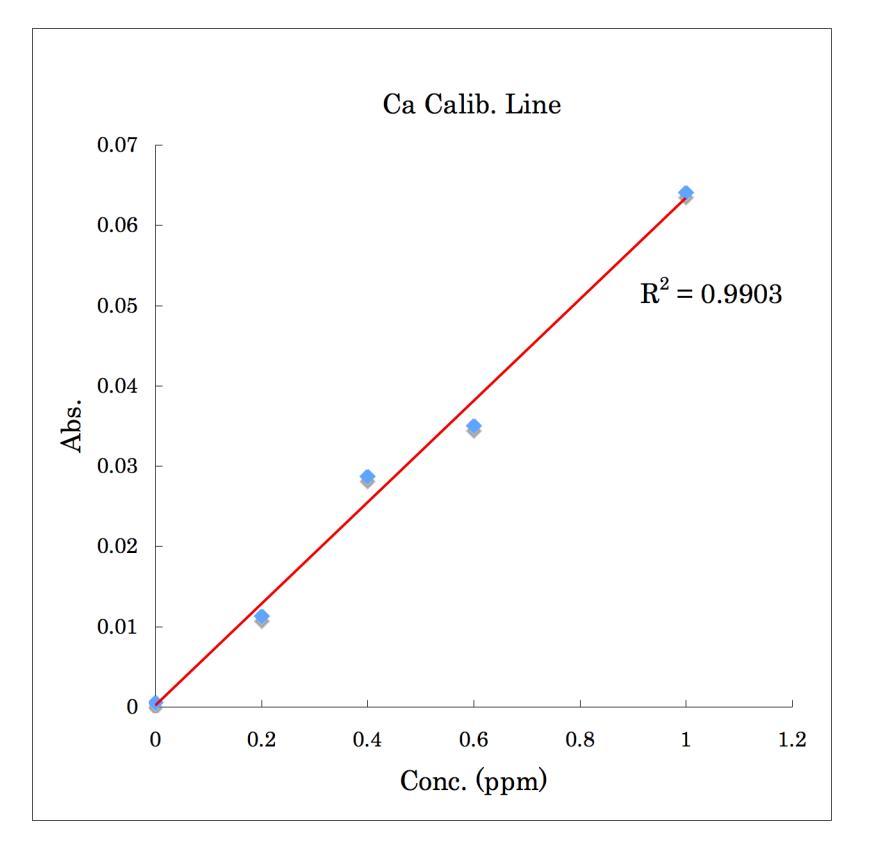
Element: Ca with C₂H₂-N₂O

Concentration (ppm)	Absorbance	Standard division
0	0.00057	0.00075
0.2	0.01131	0.00040
0.4	0.02876	0.00084
0.6	0.03507	0.00080
1.0	0.06411	0.00160

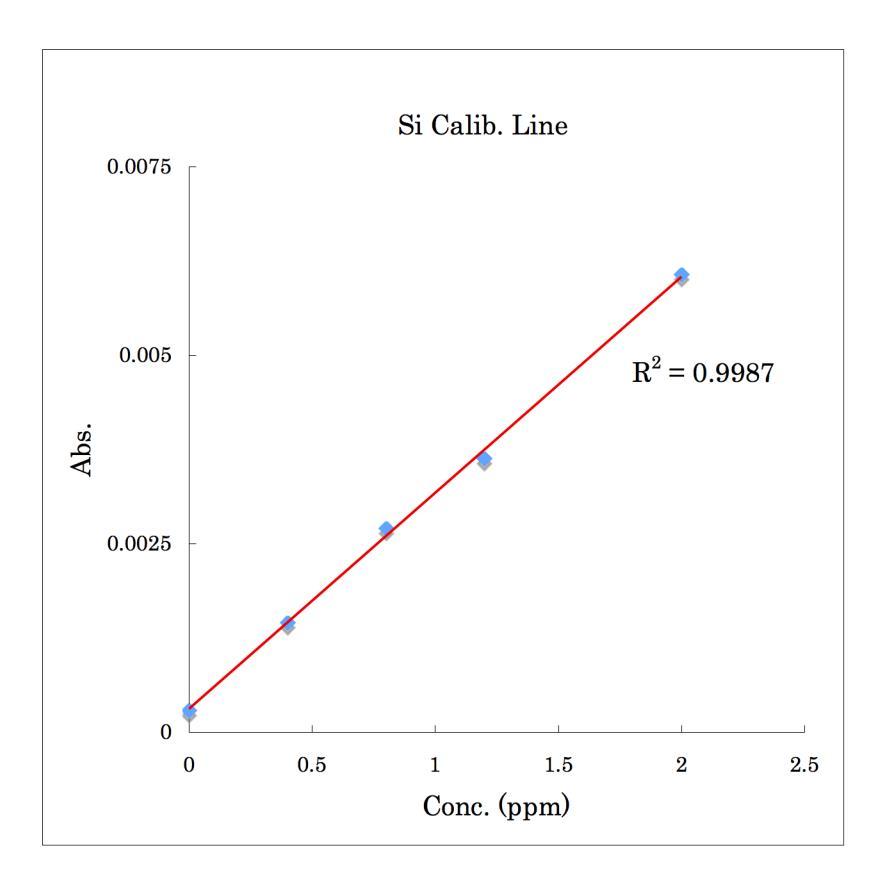
Element: Si with C₂H₂-N₂O

Concentration (ppm)	Absorbance	Standard division
0	0.00029	0.00004
0.4	0.00145	0.00016
0.8	0.00270	0.00004
1.2	0.00363	0.00010
2.0	0.00607	0.00017

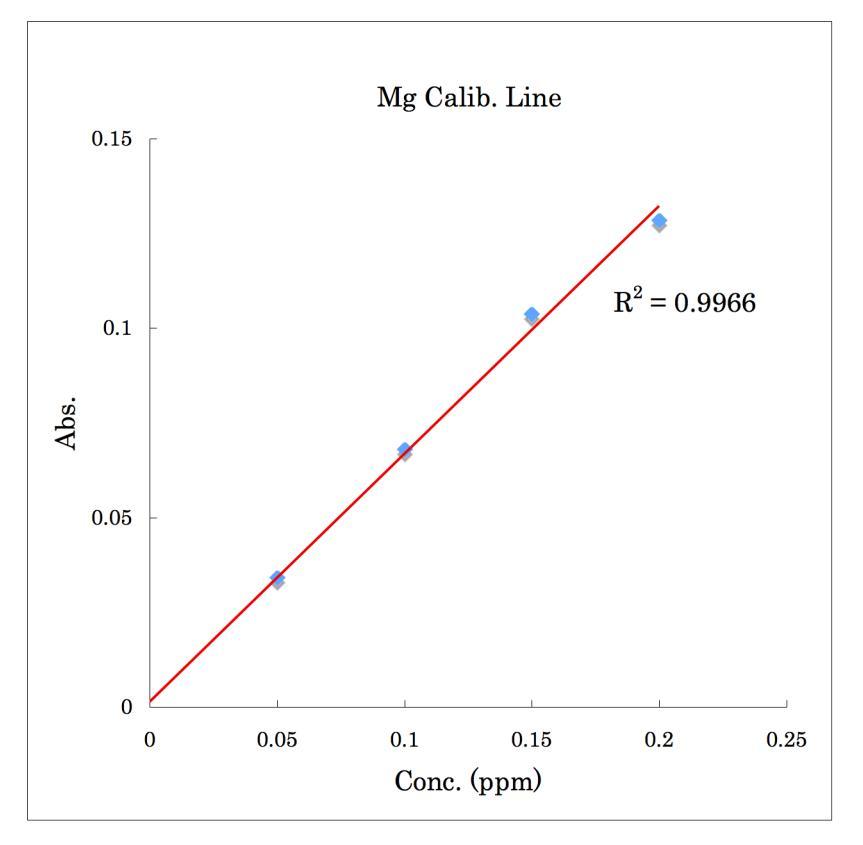
Element: Mg with C_2H_2 -Air

Concentration (ppm)	Absorbance	Standard division
0	-0.00039	0.00007
0.05	0.03420	0.00059
0.10	0.06812	0.00041
0.15	0.10374	0.00250
0.20	0.12851	0.00190

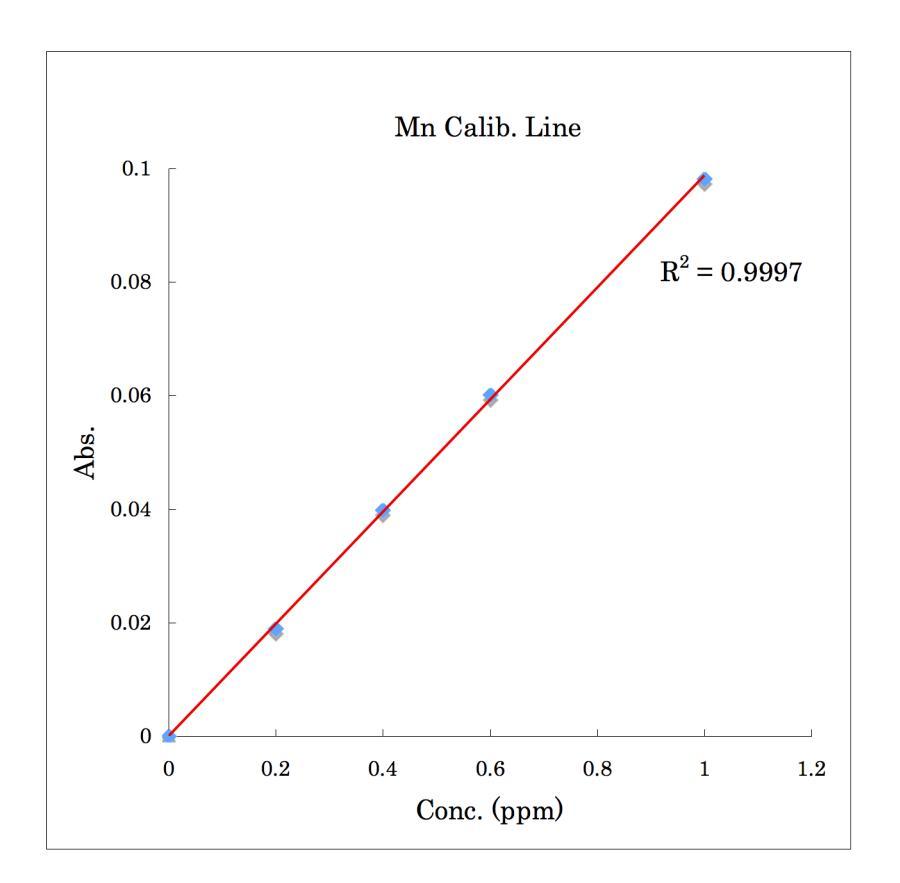
$Element: Mn \ with \ C_2H_2 \text{-} Air$

Concentration (ppm)	Absorbance	Standard division
0	-0.00001	0.00003
0.2	0.01901	0.00034
0.4	0.03984	0.00018
0.6	0.06021	0.00064
1.0	0.09815	0.00153
